# Debris/Ice/TPS Assessment and Integrated Photographic Analysis for Shuttle Mission STS-59

DEBRIS/ICE/TPS ASSESSMENT  
AND  
INTEGRATED PHOTOGRAPHIC ANALYSIS  
OF  
SHUTTLE MISSION STS-59

April 9, 1994

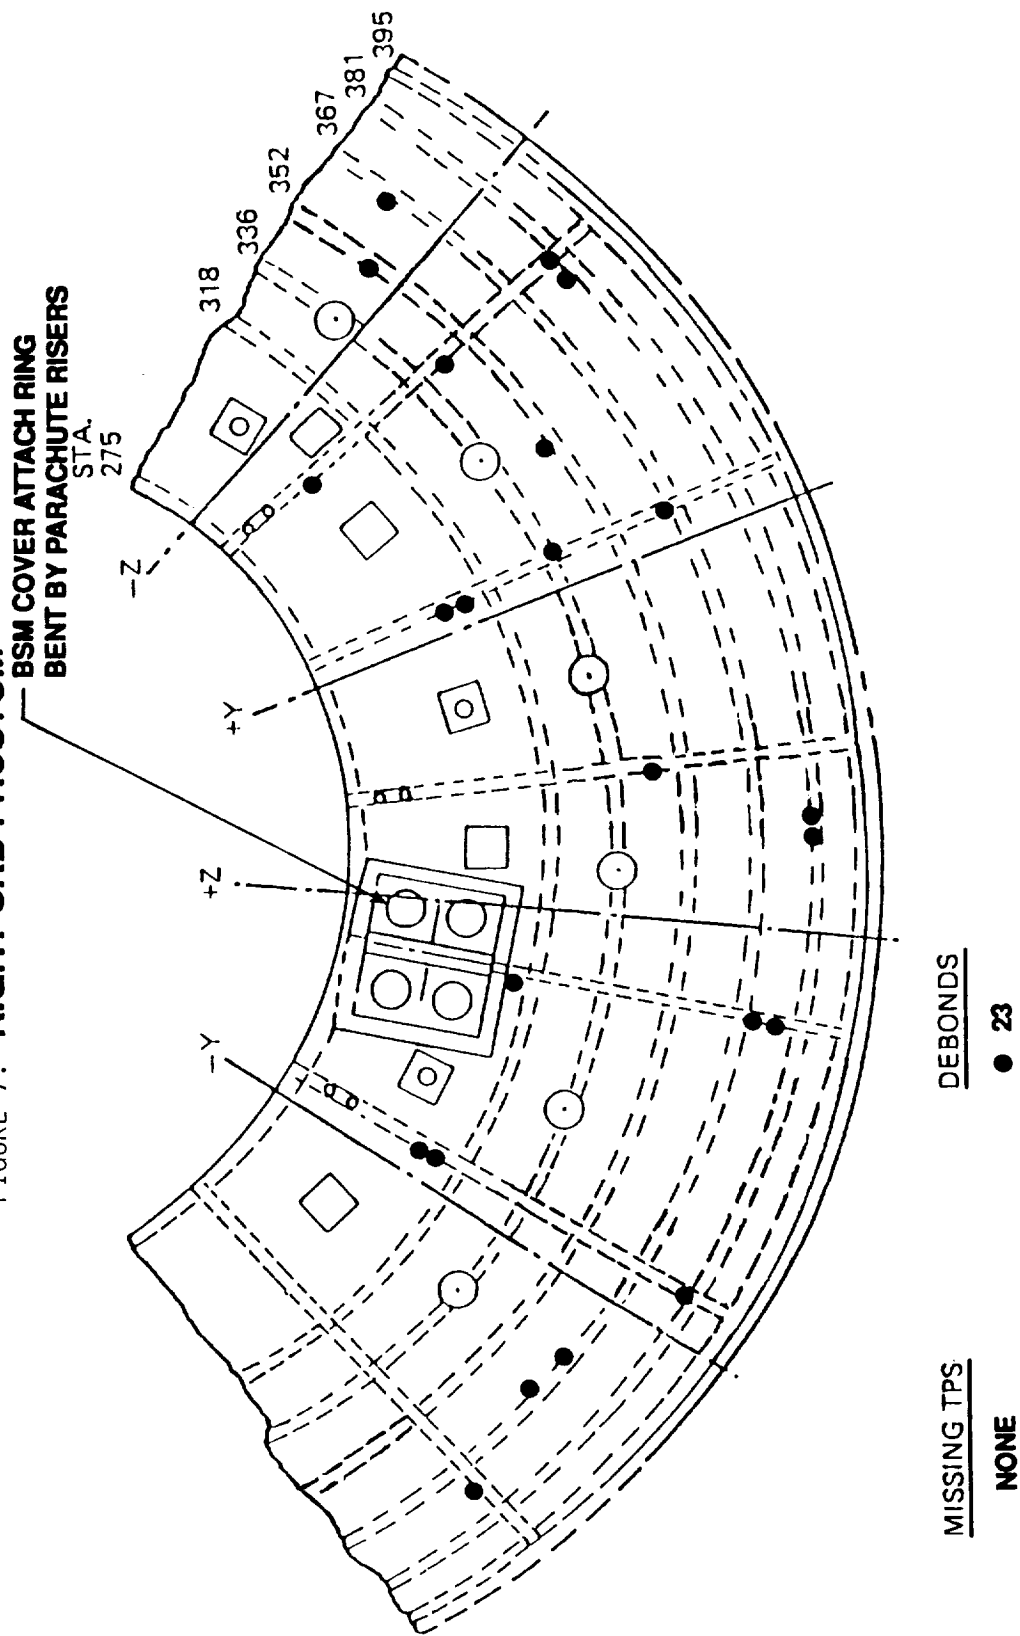
**STS-59**  
**FIGURE 7. RIGHT SRB FRUSTUM**

The RH frustum was missing no TPS but had 23 MSA-2 debonds over fasteners (Figure 7). There was virtually no blistering of the Hypalon paint with the exception of minor localized blistering along the 395 ring. All BSM aero heat shield covers had locked in the fully opened position though the upper right cover attach ring had been bent by parachute riser entanglement.

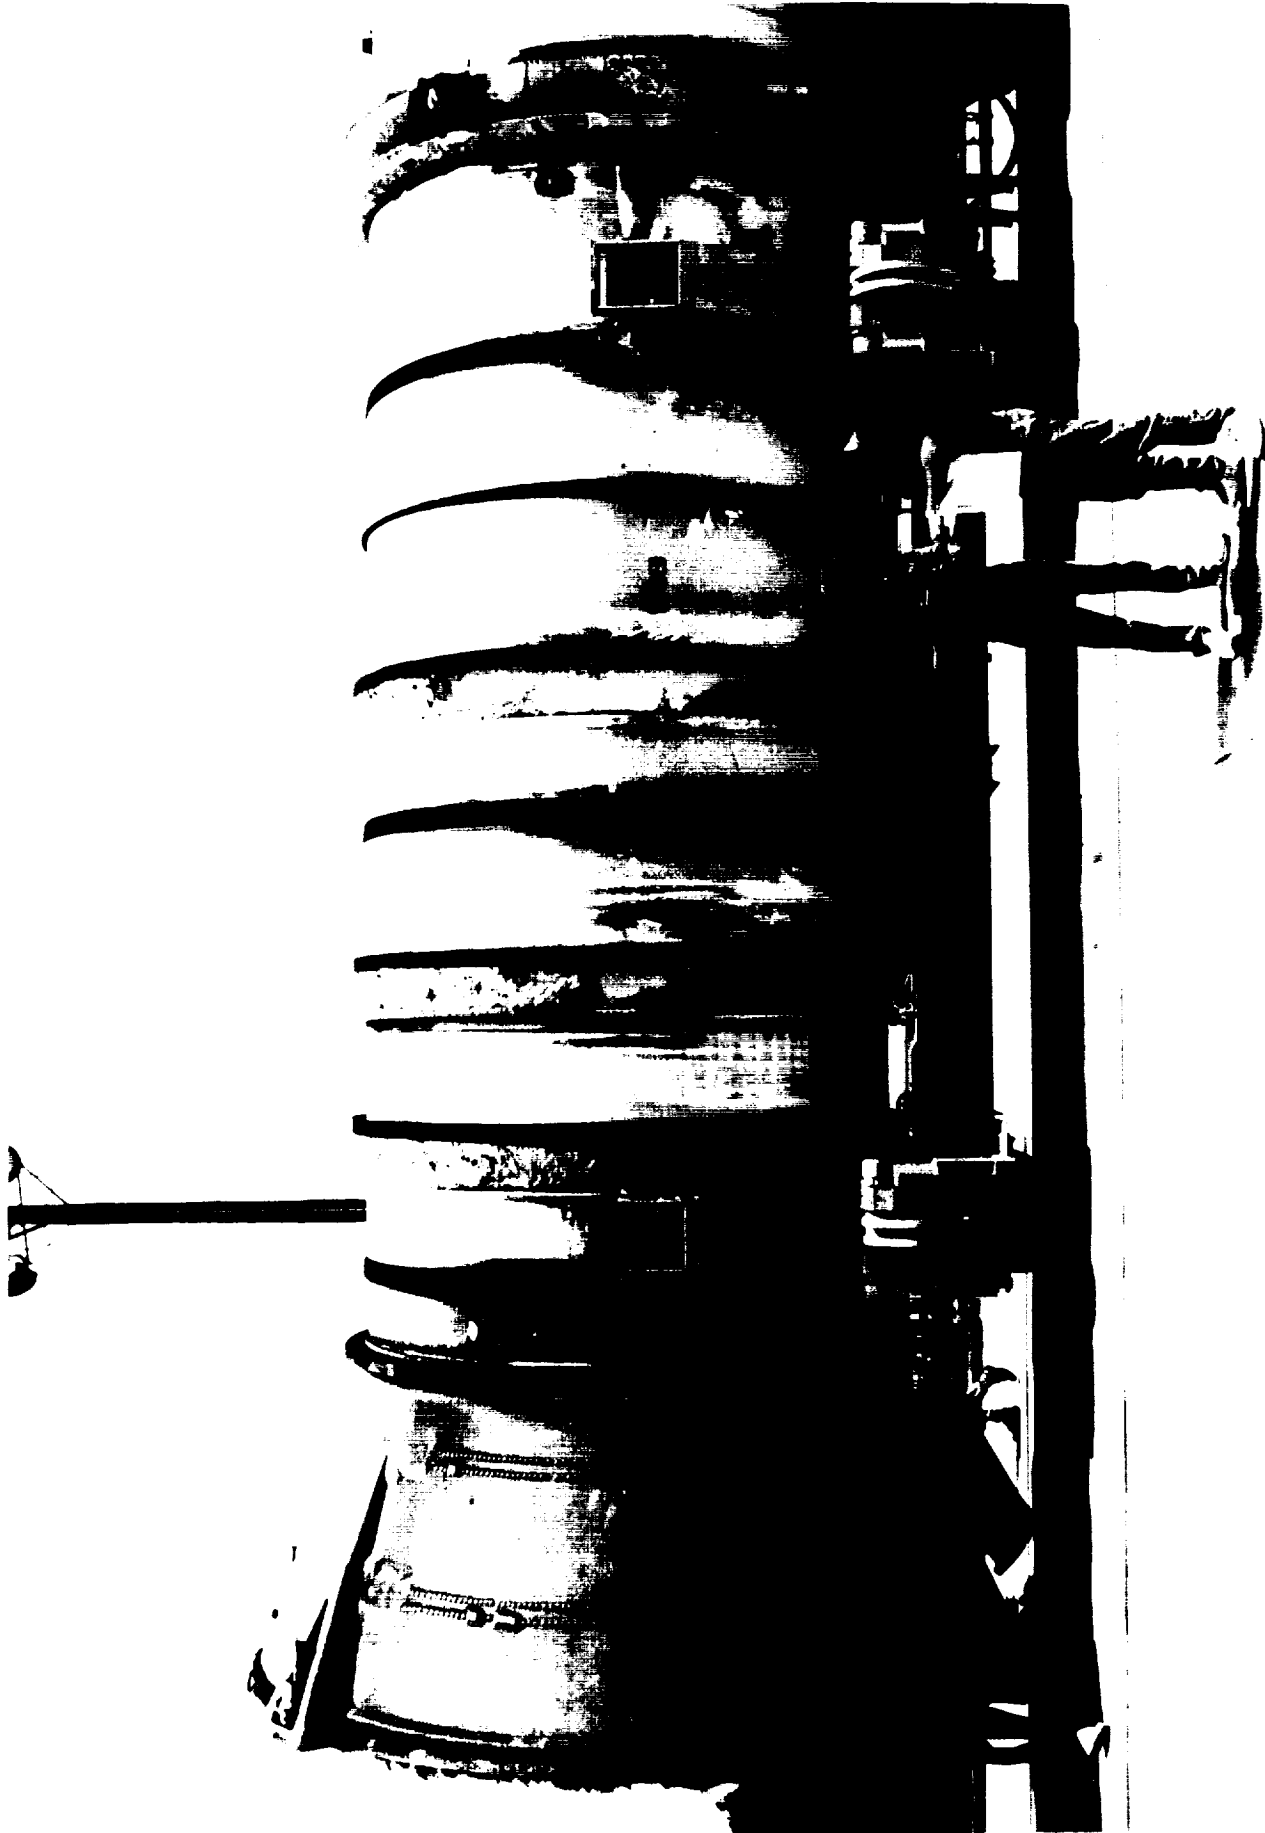
Both RSS antennae covers/phenolic base plates were intact,  
though the #2 antenna base plate had delaminated.

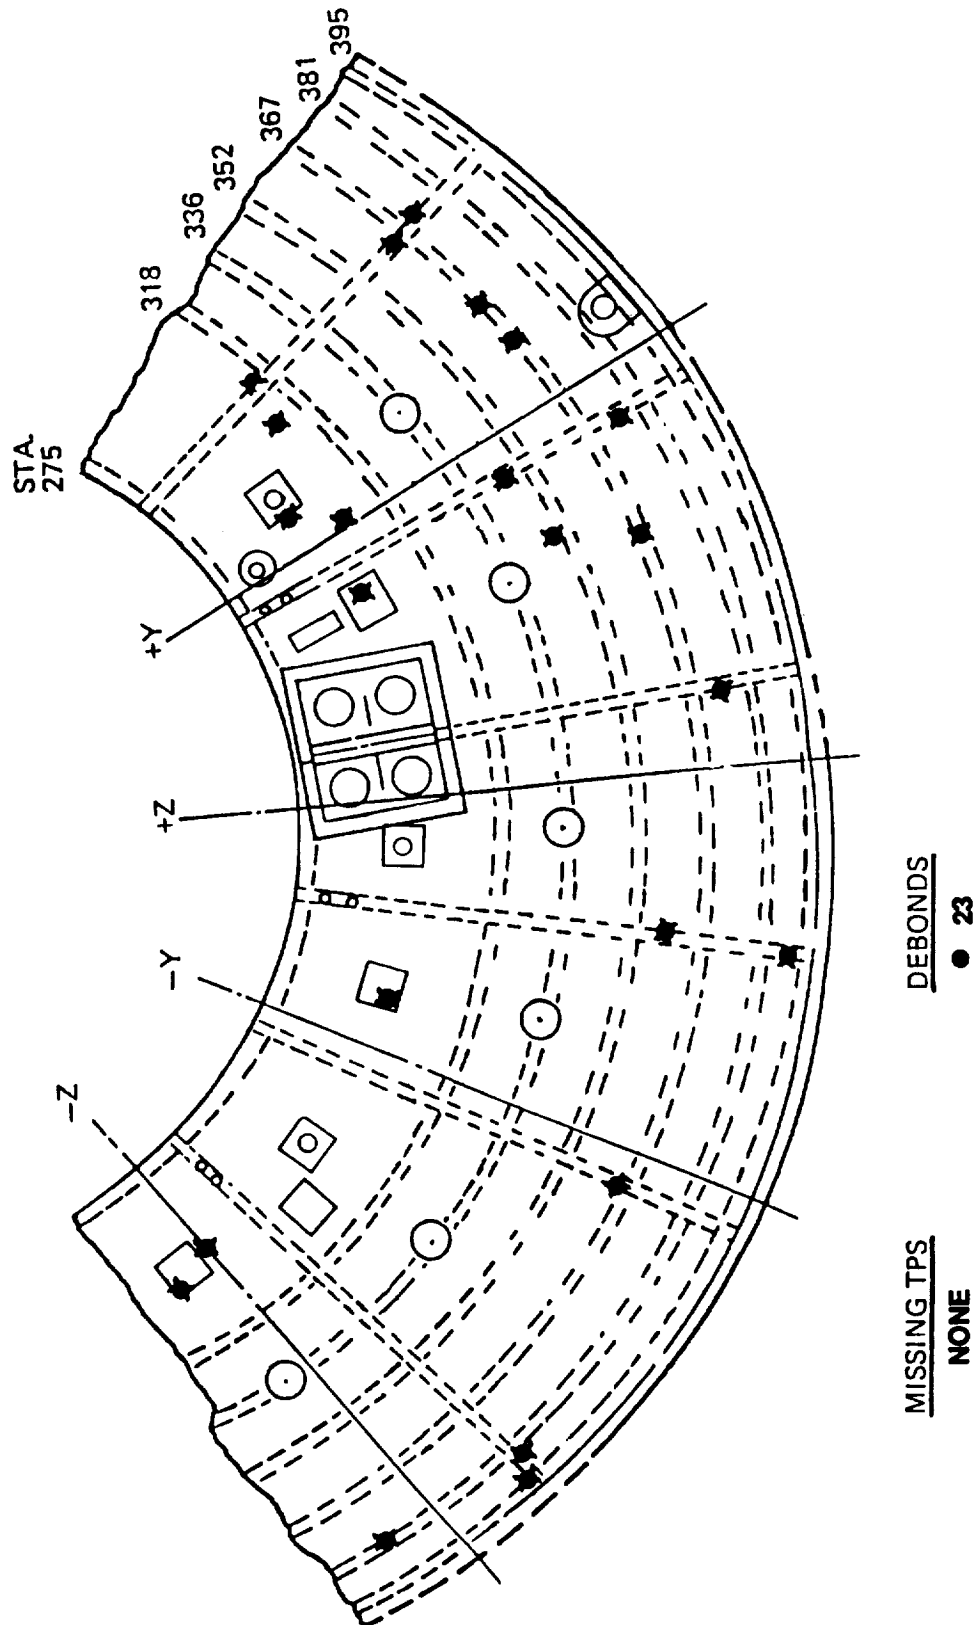
**STS-59**  
**FIGURE 8. LEFT SRB FRUSTUM**

The LH frustum was missing no TPS but had 17 MSA-2 debonds over fasteners and 6 debonds over acreage (Figure 8). Significant amounts of BTA had been applied to closeouts on this frustum. Hypalon paint was blistered/missing over the areas where the BTA had been applied. The underlying BTA was not sooted. All BSM aero heat shield covers had locked in the fully opened position.

The LH frustum had a total of 17 MSA-2 debonds over fasteners and 6 acreage debonds. Significant amounts of BTA had been applied as a closeout material on this frustum.

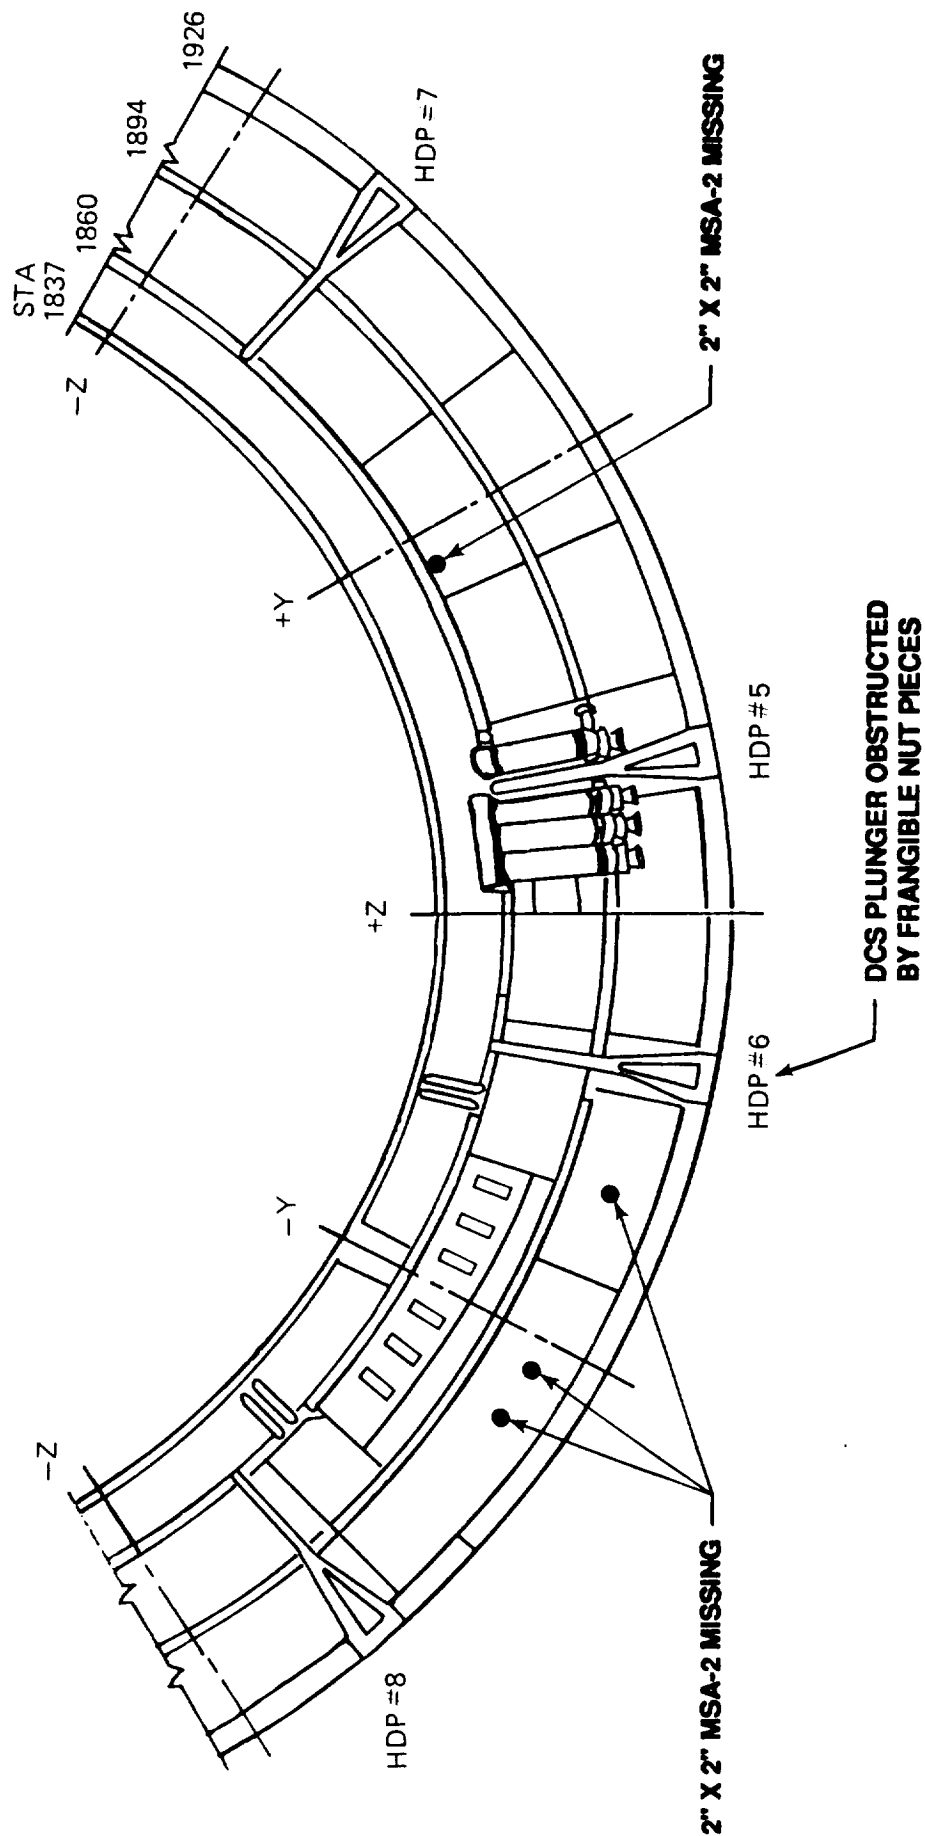
**STS-59**  
**FIGURE 9. LEFT SRB AFT SKIRT EXTERIOR TPS**

The phenolic material on the kick ring was delaminated. Aft skirt acreage TPS was generally in good condition (Figure 9). Two by two inch pieces of MSA-2 were missing from fasteners near the hydrazine servicing ports (3 places) and on the 1860 ring frame near the +Y axis (1 place). Hypalon paint was blistered over areas where BTA had been applied. The underlying BTA was generally not sooted.

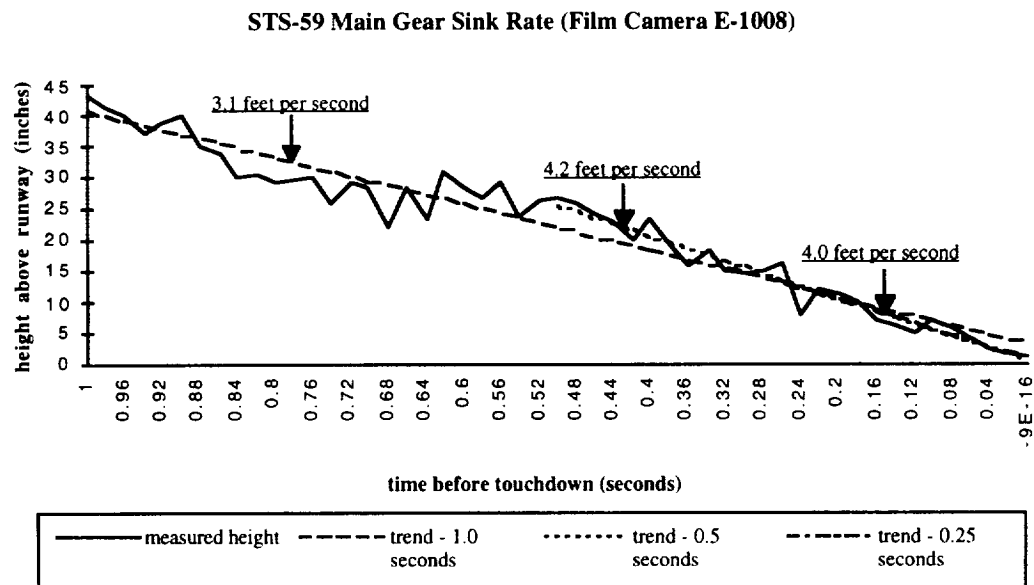
**Figure 2.6.1.1a Main Gear Sink Rate Determination from Film**

Camera E-1008 was used to determine the sink rate of the main gear. Data was gathered for approximately 1 second prior to landing from film with a frame rate of 100 frames per second. Scale information was determined by using the main gear diameter (44 inches) as a reference. A point on the runway immediately beneath the wheel was taken as reference. The motion of each point was tracked for one full second. This height was then regressed with respect to time, and the slope of the trend line was defined as the sink rate. Measures of the sink rate were calculated over the full second prior to touchdown, the last half second, and the last quarter second. Over these three intervals, the corresponding main gear sink rates were determined to be 3.1 feet per second, 4.2 feet per second and 4.0 feet per second.

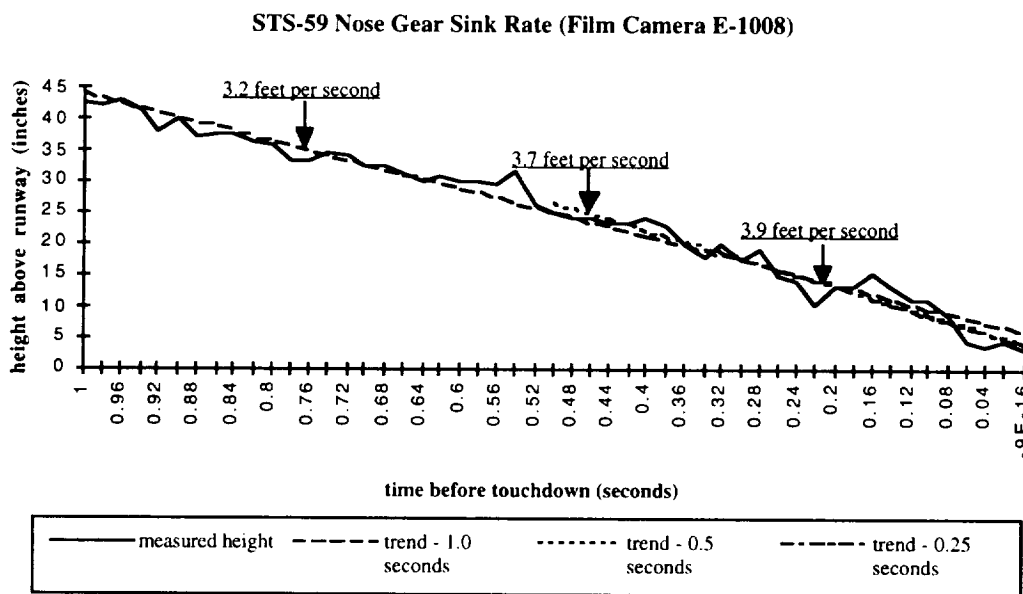
**Figure 2.6.1.1b      Nose Gear Sink Rate Determination from Film**

The same scale reference was used in the calculation of the nose gear sink rate. Data was gathered for approximately 1 second prior to touchdown from the E-1008 film. In addition to the top and bottom of the main gear, an additional scale check was obtained using the SSME bell diameters. These scaling factors appeared to agree closely with each other. The bottom of the left nose wheel was tracked for a full second. This height was then regressed with respect to time, and the slope of the trend line was defined as the sink rate. Measures of the sink rate were calculated over the full second prior to touchdown, the last half second, and the last quarter second. Over these three intervals, the corresponding nose gear sink rates were determined to be 3.2 feet per second, 3.7 feet per second and 3.9 feet per second.

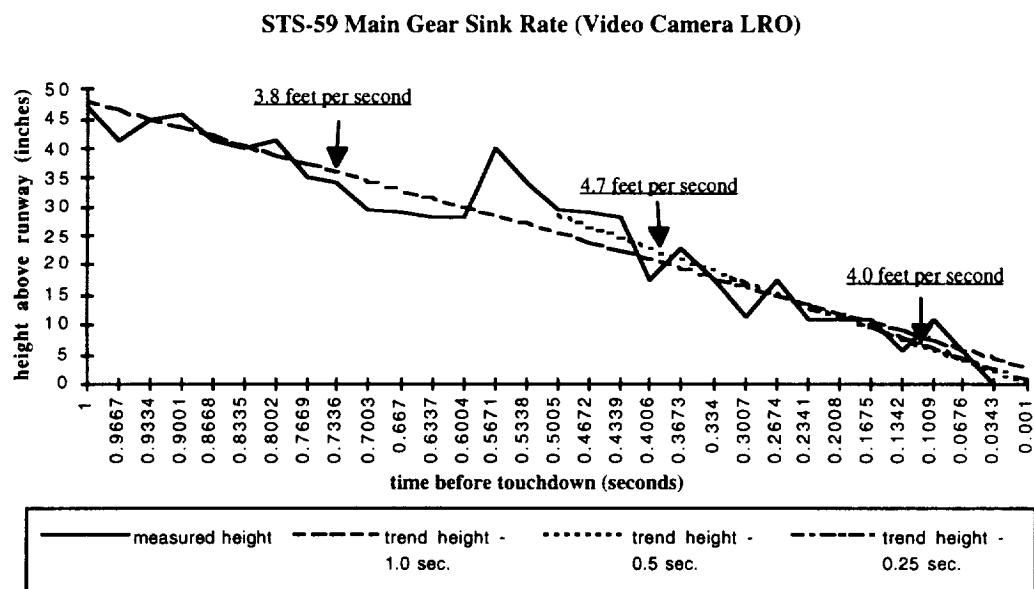
**Figure 2.6.1.2a Main Gear Sink Rate Determination from Video**

Camera LRO was used to determine the sink rate of the main gear. Data was gathered for approximately 1 second prior to landing from the video (frame rate of 30 frames per second.) Scale information was determined by using the rudder speed brake (201 inches) as a reference. A point on the runway immediately beneath the wheel was taken as reference. The motion of each point was tracked for one full second. This height was then regressed with respect to time, and the slope of the trend line was defined as the sink rate. Measures of the sink rate were calculated over the full second prior to touchdown, the last half second, and the last quarter second. Over these three intervals, the corresponding main gear sink rates were determined to be 3.8 feet per second, 4.7 feet per second and 4.0 feet per second.

Normally, sink rate is calculated from end-of-runway cameras which are thought to provide the best results. While the nose gear sink rates calculated from film and video agreed closely, the measured main gear sink rates differed between film and video by 0.7 feet per second. However, upon close examination of the graphs, one can see that the slope varies similarly as a function of time. The implication is that the scaling factor for one of the two sources may be off because of viewing angle discrepancies.

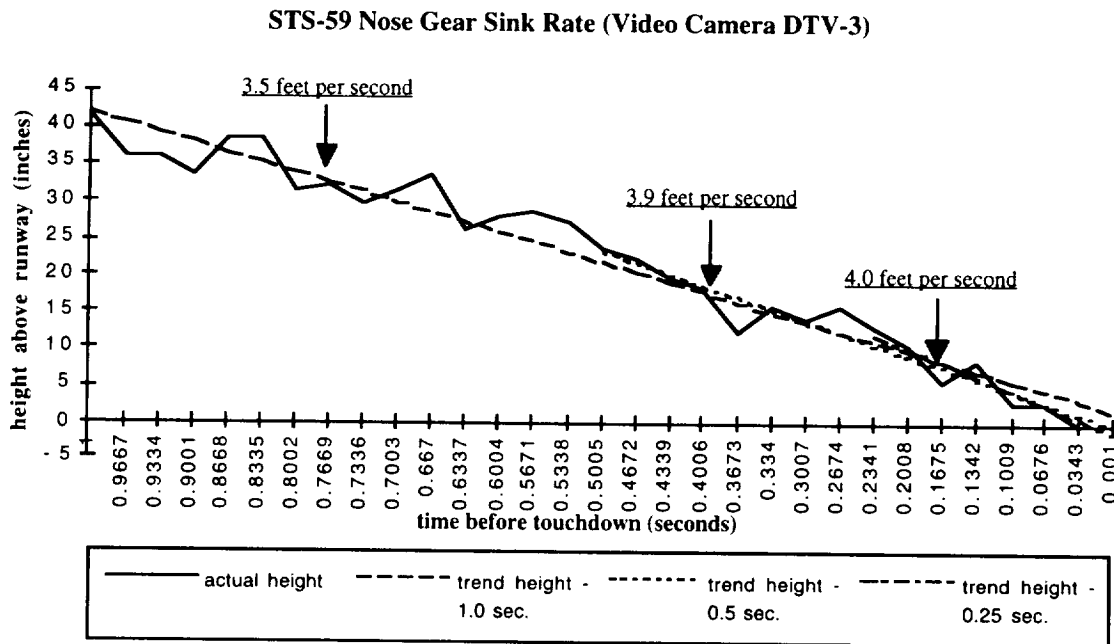
**Figure 2.6.1.2b**      **Nose Gear Sink Rate Determination from Video**

For the nose gear sink rate calculations, the main gear was used as a scale reference. Data was gathered for approximately 1 second prior to touchdown from camera DTV-3. The bottom of the left nose wheel was tracked for a full second. This height was then regressed with respect to time, and the slope of the trend line was defined as the sink rate. Measures of the sink rate were calculated over the full second prior to touchdown, the last half second, and the last quarter second. Over these three intervals, the corresponding nose gear sink rates were determined to be 3.5 feet per second, 3.9 feet per second and 4.0 feet per second.

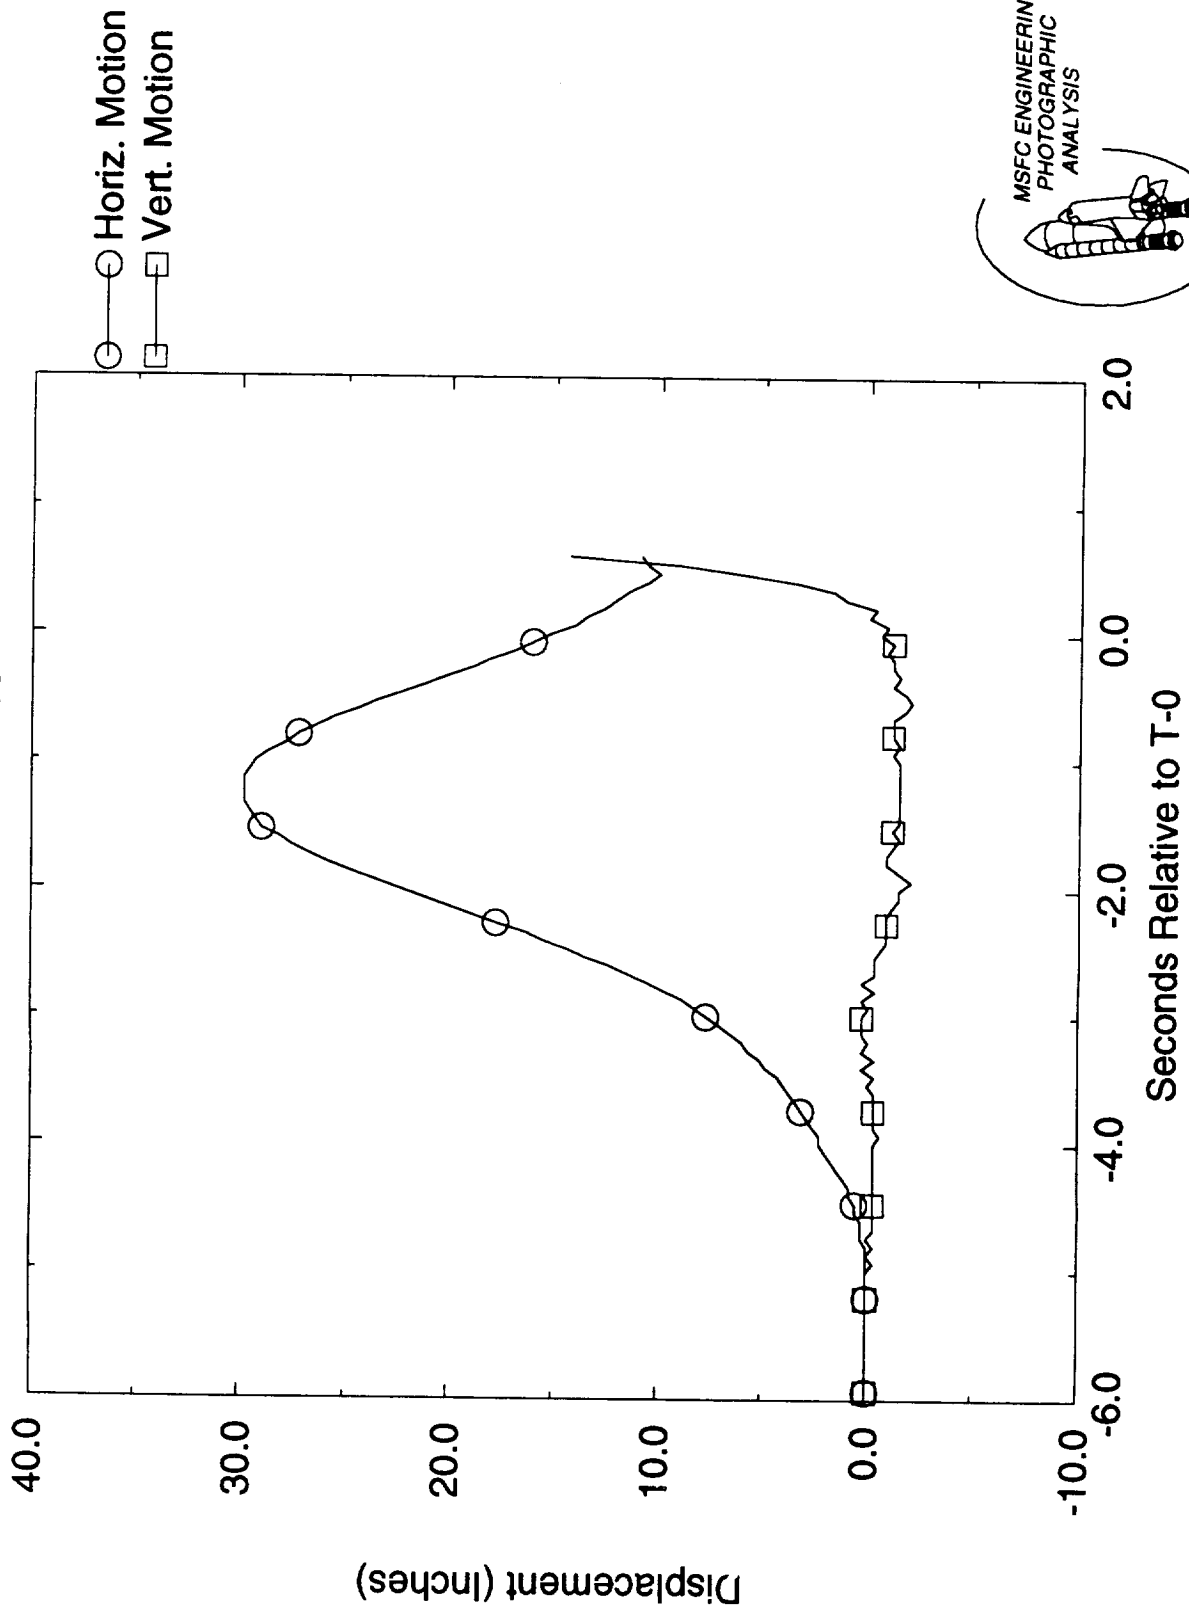
Maximum ET tip deflection for this mission was determined to be approximately 30 inches. Figure 7 is a data plot showing the measured motion of the ET tip in both the horizontal and vertical directions. A positive horizontal displacement represents motion in the -z direction. These data were derived from video camera OTV-061. Film camera E-79 was not used to measure ET tip deflection due to the low light levels at liftoff which provided a degraded image.
